Manhole Inspection Summary

Manhole # S17K__033MH

Location Address: **2515 mchenry-alley-franklin**

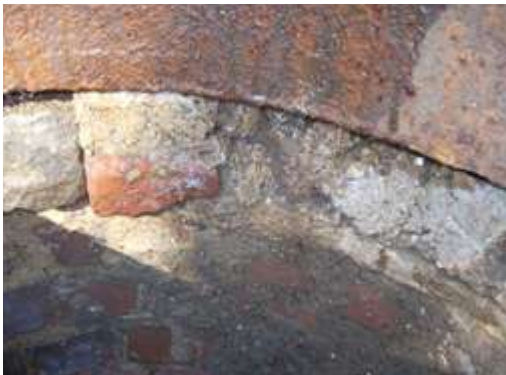
Defect 2

Condition: ☐ Sound ☐ Cracked ☐ Root Intrusion ☐ Loose Brick ☒ **Deteriorated**

deteriorated chimney

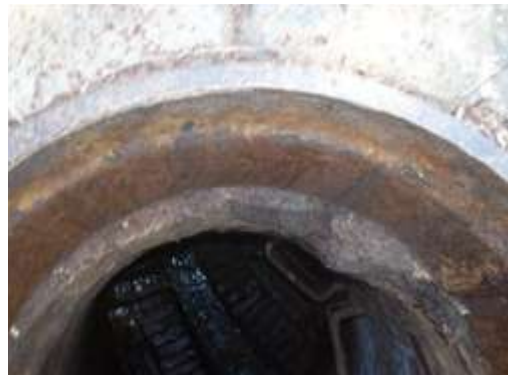
Defect 1

Frame Offset: **3** (in.) Condition: ☒ Sound ☐ Cracked ☐ Leaks

frame offset

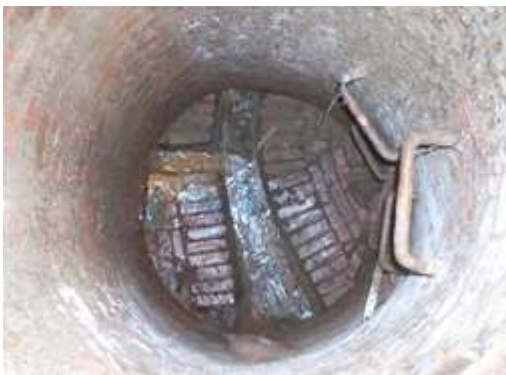
Defect

Steps Count: **5** Missing: **0** ☒ **Corroded**

corroded steps

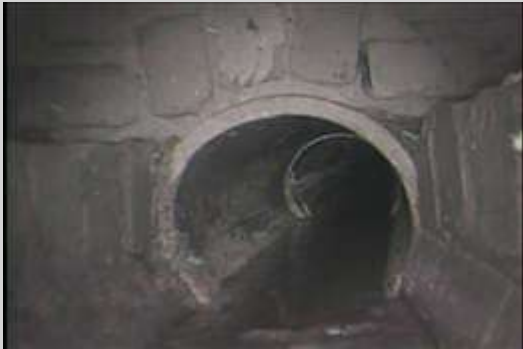
12 O'Clock Outflow

Pipe Height: **9.6** (in.) Rod and Bar (Angled)
Pipe Material: **Clay** ☐ Pipe Lined
Invert Depth: **9.72** (ft.) Flow Characteristics: **Slow**
Deposits: ☒ None ☐ Mud ☐ Sludge ☐ Debris ☐ Grease
Silt Depth: **0** (in.) Deposits Extent:
Infiltration: **None** Pipe Seal Cond: **Sound**

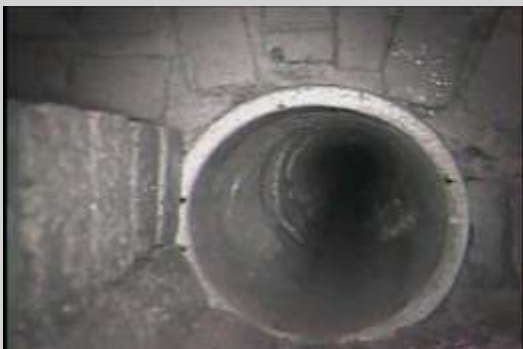
5 O'Clock Inflow

Pipe Height: **8.4** (in.) Rod and Bar (Angled)
Pipe Material: **Clay** ☐ Pipe Lined
Invert Depth: **9.69** (ft.) Flow Characteristics: **Slow**
Deposits: ☒ None ☐ Mud ☐ Sludge ☐ Debris ☐ Grease
Silt Depth: **0** (in.) Deposits Extent:
Infiltration: **None** Pipe Seal Cond: **Sound**

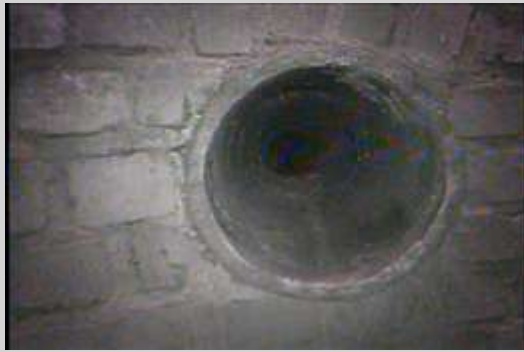
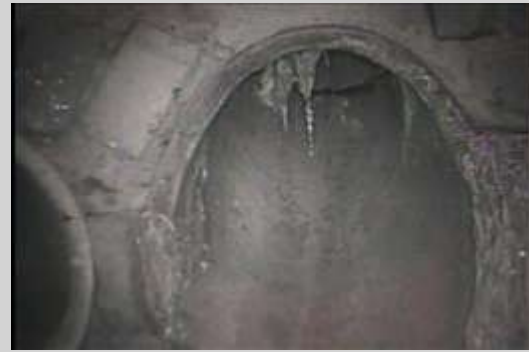
6 O'Clock Inflow

Infiltration: **None** Pipe Seal Cond: **Broken**

Drop: **Outside** Rod and Bar
Angled: **Yes** Reading: **8.49** (ft.)
Inv Depth: **9.49** (ft.)
Drop Condition: **Open**

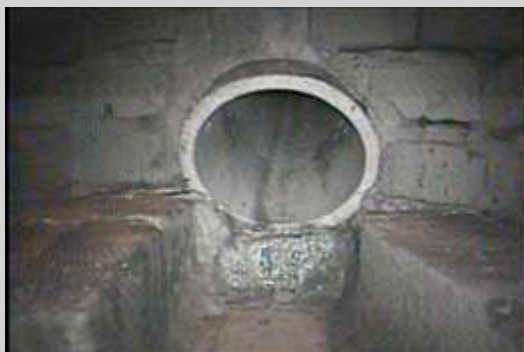
9 O'Clock Inflow

Infiltration: **None** Pipe Seal Cond: **Sound**
